THE EFFECT OF FRETTING DAMAGE ON  
THE FATIGUE BEHAVIOR OF METALS

Technical Report 1

David W. Hoepfner and Gary L. Goss

**LOCKHEED-CALIFORNIA COMPANY • BURBANK**  
A DIVISION OF LOCKHEED AIRCRAFT CORPORATION

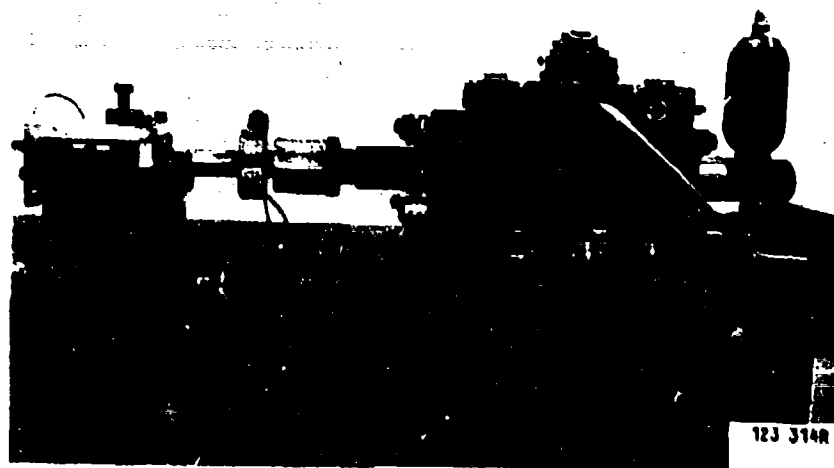
Figure 2. Overall View of the Fretting-Fatigue Test Machine(11)

The basic elements are briefly described here. The fretting-fatigue machine was developed to meet the following requirements:

- (1) A fatigue unit with axial load capability was utilized.
- (2) The mean load, alternating load, normal load, relative surface displacements, friction load, and frequency would be monitored and controlled, as desired, throughout each test.

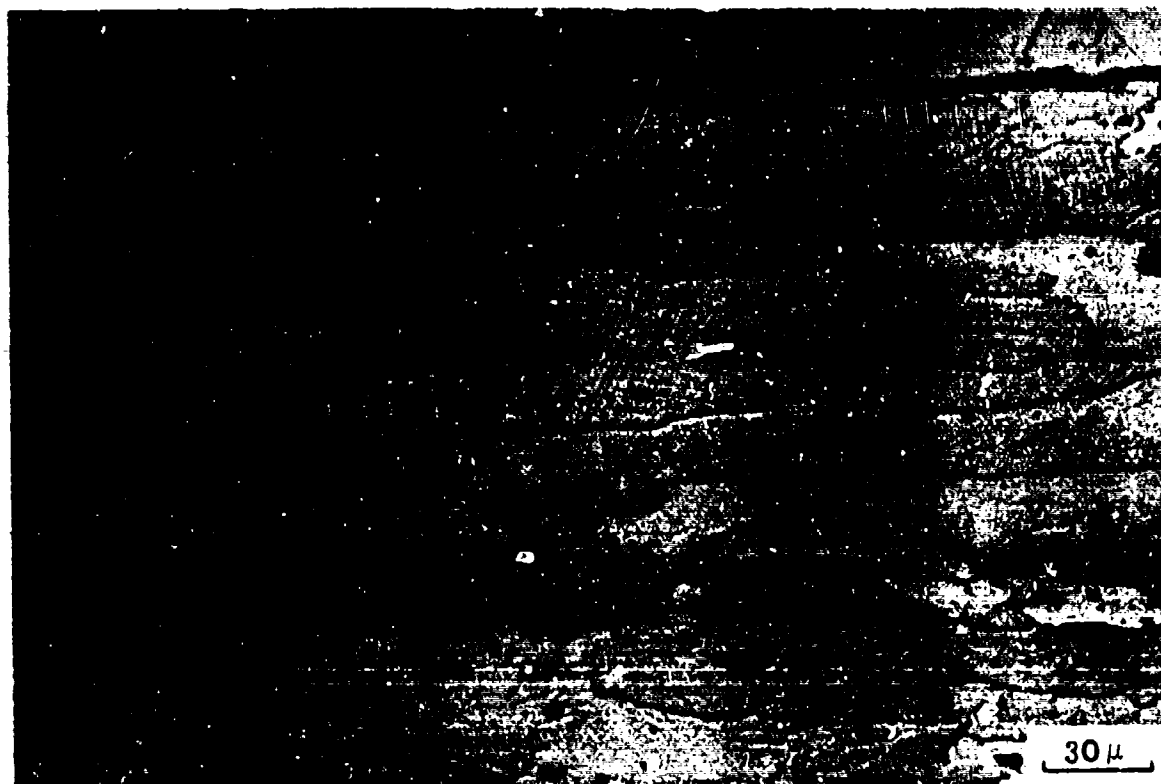
SPECIMEN NUMBER - 71-5A, 7075-T6  
 MAXIMUM STRESS - 60000 PSI  
 NORMAL PRESSURE - 3000 PSI  
 AREA LOCATION - C-C  
 DISTANCE FROM SPECIMEN EDGE - 0.060 INCH  
 DISTANCE FROM FRACTURE SURFACE - 0.078 INCH  
 DISTANCE FROM FRETTED SURFACE - ON SURFACE

Figure 22. Photomicrograph Showing Additional Secondary Crack in Figure 20
